**NASA
Technical
Paper
2190**

September 1983

Crash Tests of Three Identical Low-Wing Single-Engine Airplanes

**Claude B. Castle
and Emilio Alfaro-Bou**

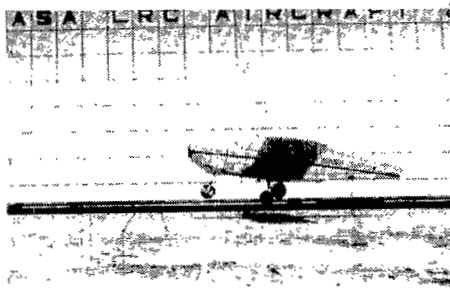
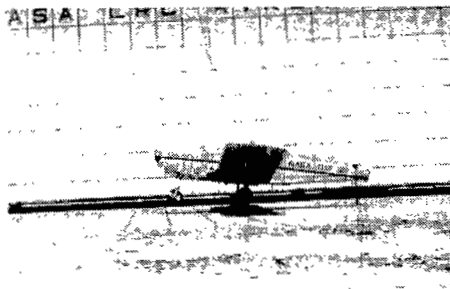
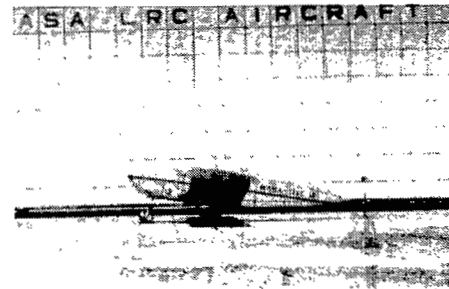
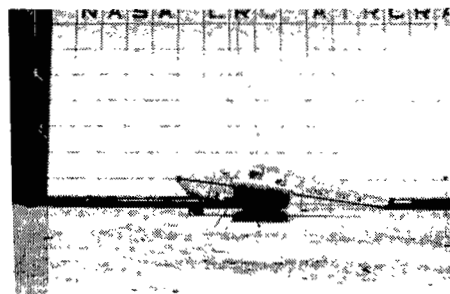
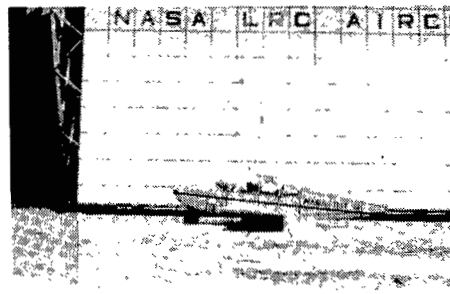
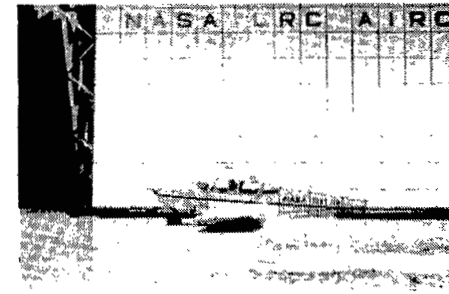
Figure 9.- Crash-sequence photographs of 10° test on concrete (hard landing).

Crash sequence.- The photographs in figure 9 illustrate the crash sequence of a simulated 10° test on concrete (hard landing) from prior to touchdown through initial slide-out. The airplane specimen contacted the concrete impact surface on its main landing gear at a flight-path velocity of 24.6 m/sec along a flight-path angle of -15°, resulting in a sink velocity of 6.4 m/sec. The nose gear then contacted the ground. The airplane settled on the landing gears which caused them to stroke completely and to fracture the left gear (frame 5) and then it continued to slide out at approximately the same attitude as at impact. Inside the cabin, a slight movement of the dummies was seen.

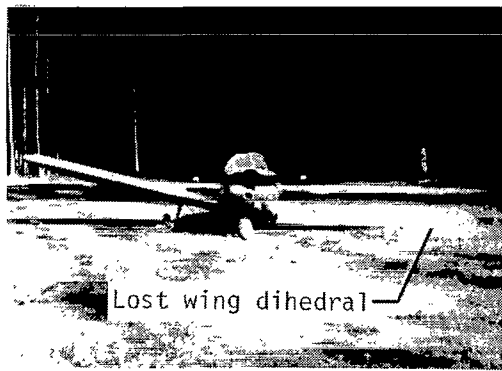
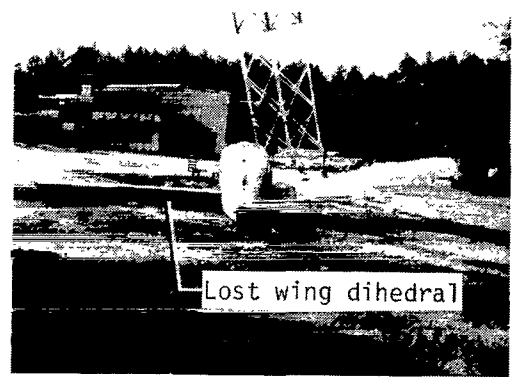
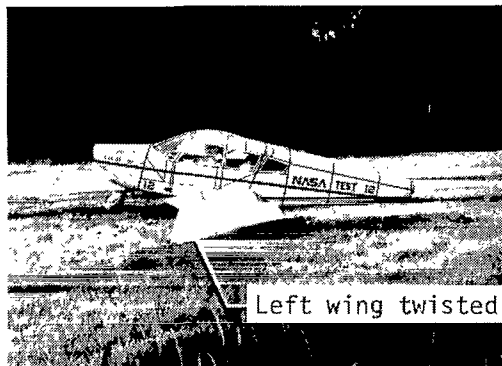
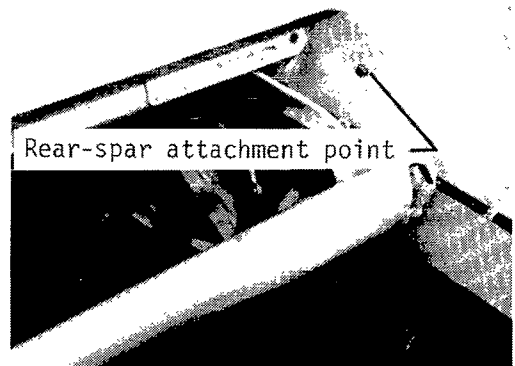
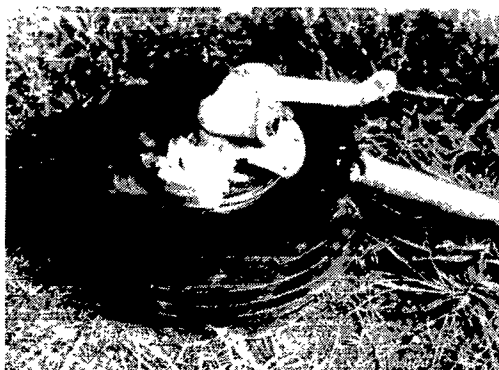
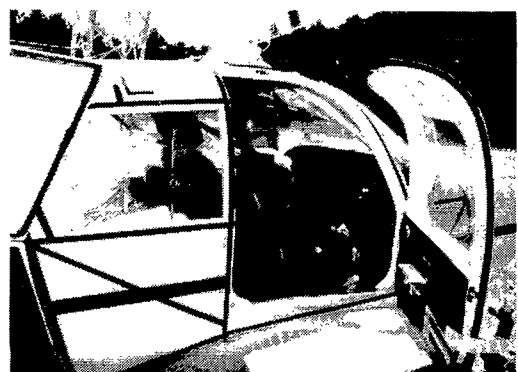
Figure 10.- Postcrash external damage to test specimen in 10° test on concrete (hard landing).

Assessment of damage.- Postcrash photographs of the external damage sustained by the airplane test specimen are presented in figure 10. The livable cabin volume (a volume sufficient in size to maintain space between the occupants and the structure) was maintained during the crash impact. In figure 10(a), the airplane is shown resting on its left wing, right landing gear, and nose wheel. All three tires experienced a blowout. The nose-gear fork bent and twisted as shown in figures 10(a) and (c). The twisted left wing, with no dihedral, the broken linkage for the inboard flap, the sheared rear-spar attachment bolt, and the sheared fore-wing attachment to the fuselage are shown in figures 10(a), (b), (c), and (d), respectively. The fuselage is shown to be in good overall condition except for a slight deformation at the interface with the inboard left-wing flap. Figure 10(e) shows the damaged left land-

ing gear with the fractured shock absorber. Figure 10(f) shows the crew compartment, the pilot and copilot dummies, and their restraints. The overall lack of structural damage by this test is also shown in figure 10(f).

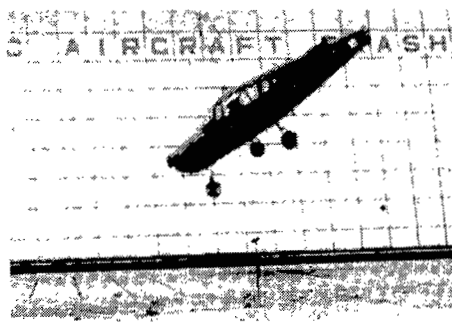
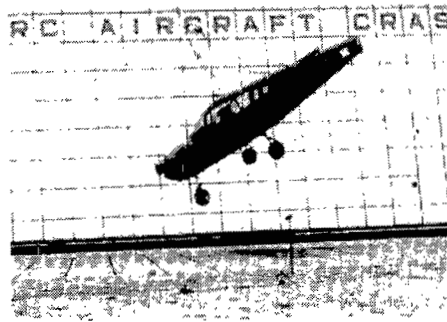
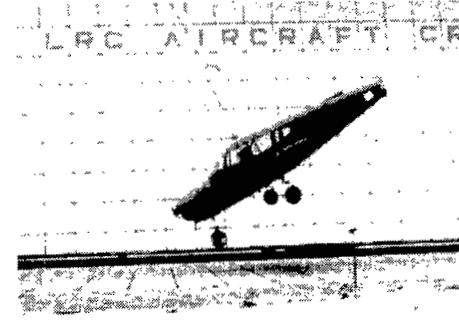
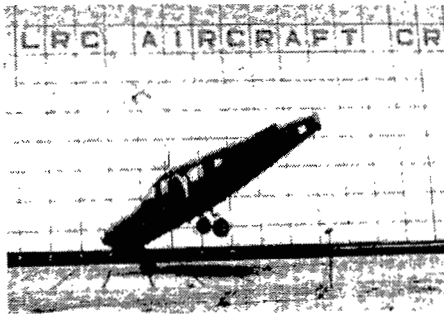
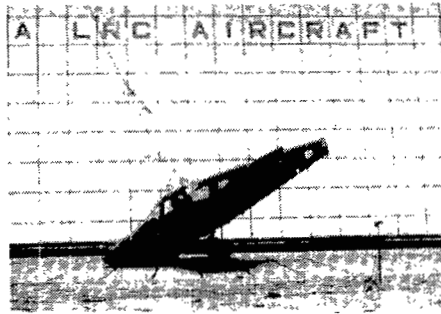
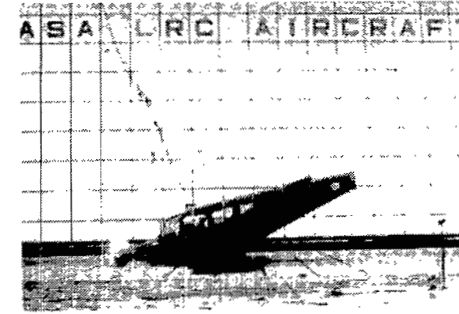
Figure 11.- Crash-sequence photographs of -30° (nose-down) test on concrete.

Crash sequence.- The photographs in figure 11 illustrate the crash sequence of a -30° pitch (nose-down) impact test starting prior to touchdown through a part of the slide-out. The airplane specimen contacted the concrete impact surface on its nose wheel at a flight-path velocity of 24.6 m/sec (sink velocity of 11.9 m/sec (frame 4)). The nose gear then collapsed (frame 5) and finally embedded in the floor in the baggage compartment (cabin cargo area). Afterwards, the airplane nose, followed by the main landing gears, contacted the ground. As the airplane continued its travel, the fuselage rotated downward, the airplane nose crushed, and the main landing gears collapsed which forced the wings to twist (frame 6). At the onset of the decelerating forces (frame 5), the pilot and copilot started to pitch forward and their upper torso lurched toward the instrument panel (frames 6 and 7). Most of the crushing and damage to the airplane took place at the time recorded in frame 6. Frames 7, 8, and 9 show the airplane settling on the impact surface and sliding out.

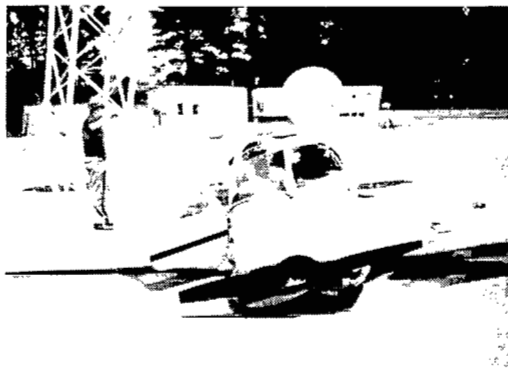
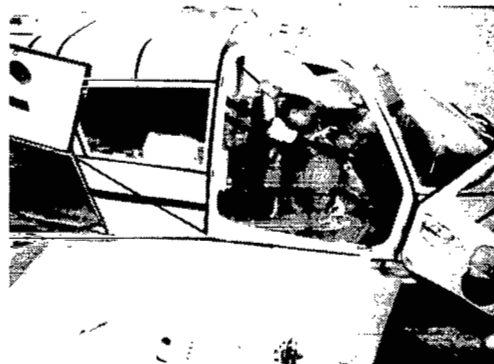
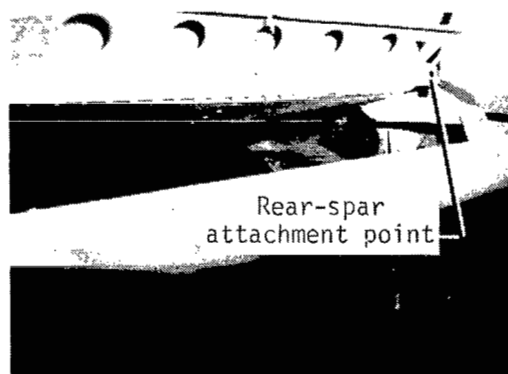
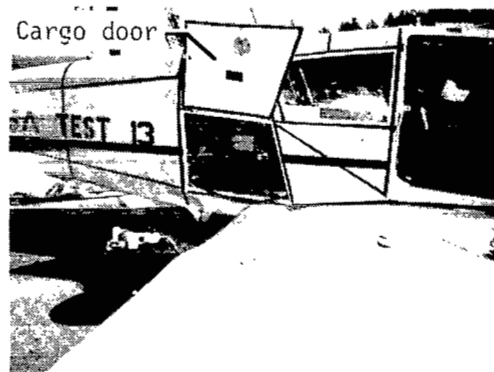
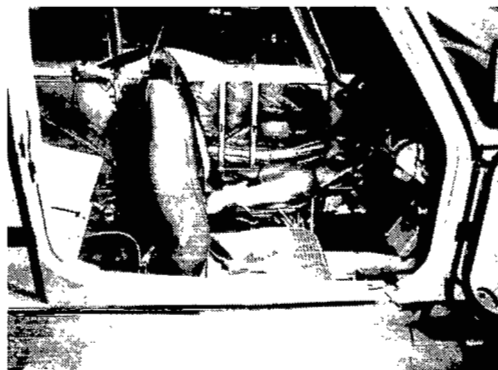
Figure 12.- Postcrash damage to test specimen in -30° (nose-down) test on concrete.

Assessment of damage.- Postcrash photographs of the damage sustained by the airplane specimen are shown in figure 12. Figure 12(a) shows the airplane in its final position resting on the fuselage and wings. The nose and main landing gears fractured and collapsed and the tires blew out during the impact. Both windshields broke and the center post between the windshields bent. Some of the front damage can be seen under the engine cowling. The impact force caused part of the lower fire wall to protrude about 20 cm into the cabin. Both wings lost their dihedral, and the left wing is shown propped by the collapsed landing gear. The balloon seen in figure 12(a) was part of an Emergency Locator Transducer (ELT) experiment for locating a crashed airplane by visible means.

Figure 12(b) shows the pilot and copilot dummies restrained to their seats after the airplane came to a stop. Also shown is buckling of the airplane nose and side panel over the wing. The space between the seats and instrument panel, as well as the livable cabin volume, was maintained. Figure 12(c) shows the left inboard-flap control broken, the rear-spar attachment pin sheared off, and some buckling in the fuselage skin. Figure 12(d) shows a collapsed landing gear and buckling of the skin under and aft of the cargo door. In figure 12(e), the nose wheel is seen embedded in the floor of the rear cabin. Also shown is the rear-cabin-floor upheaval aft of the passenger compartment, the transducer junction box, and the pyrotechnic programmer box. Figure 12(f) shows a slight deformation in the aft member of the doorframe and a fracture in the lower front corner. Other damage to the airplane, not shown in these photographs, was buckled skin from the airplane nose to the third left window, a buckled wing at the attachment point to the fuselage forward of the main spar, a cracked first-passenger window, a collapsed left landing gear, and a failed copilot seat rail at the rear-legs attachment point.

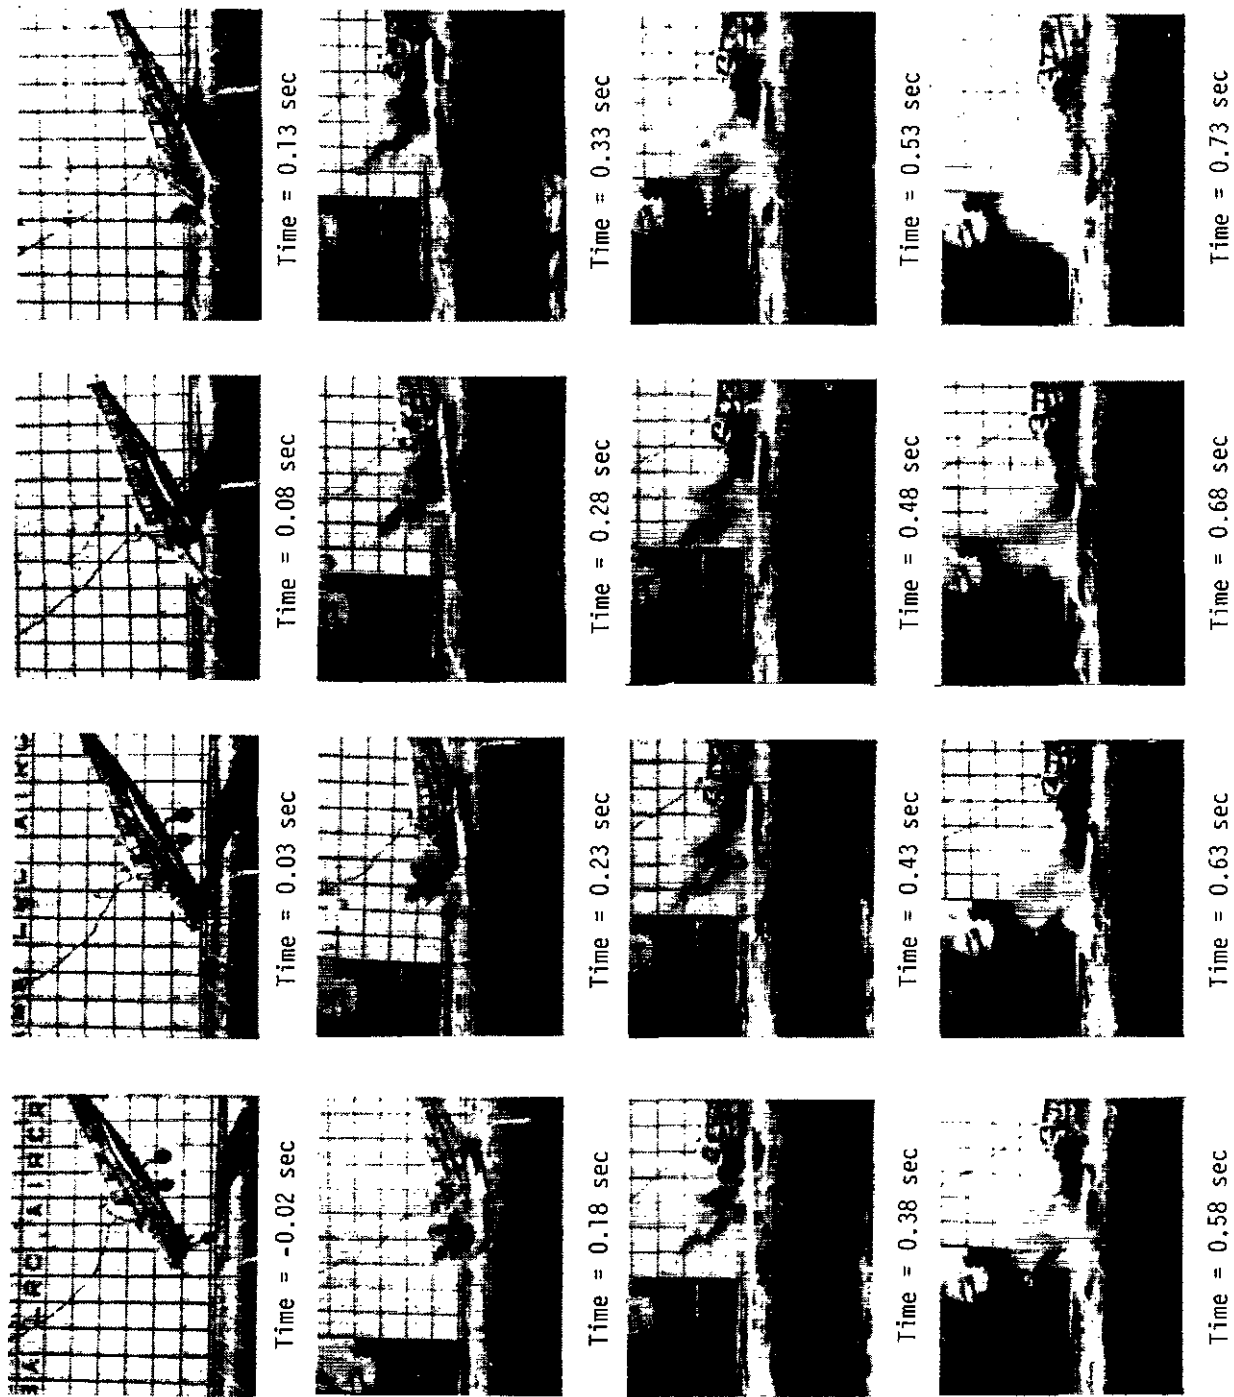
Figure 13.- Crash-sequence photographs of -30° (nose-down) test on soil.

Crash sequence.- The crash sequence of a -30° pitch (nose-down) impact test on a soil surface is illustrated in figure 13. The sequence starts prior to touchdown and ends when the scattered soil starts to settle after the abrupt impact. The airplane specimen contacted the soil impact surface on its nose wheel at a flight-path veloc-

ity of 24.6 m/sec (a sink velocity of 12.9 m/sec). The nose gear then collapsed (frame 2) and later lodged in the lower half of the fire wall during crushing of the airplane nose. The nose of the airplane started to crush (frame 3), and the main landing gears contacted the ground.

As the airplane decelerated, the dummies started to pitch forward (frame 3) and lurched forward out of the view in frame 4. The pilot's shoulder harness can be seen taut and fully extended holding the displaced dummy (frame 4). Frame 4 also shows that the nose of the airplane has crushed to the fire wall, the engine cowling has come off, the landing gears have collapsed, the wings have contacted the ground, and buckling of the structure has occurred on the top and side of the fuselage.

Frame 5 shows further compression of the fuselage with heavy damage extending up to the pilot's window. The aft part of the left wing has started to separate from the fuselage. Bending of the roof has occurred aft of the pilot's window, and the engine cowling has completely separated from the airplane. The pilot and copilot dummies have bounced back to the seated position, and fire wall has protruded into the crew area, thus reducing the space between the fire wall and the crew seats. The first-passenger dummy is bent forward over its knees and, in frame 6, has started to rebound. The left wing continues to separate from the fuselage at the main spar while pivoting forward. In frame 7, the wing has separated from the main spar and more recovery in the first-passenger dummy is shown. Frame 8 shows the pilot dummy flexing forward, the first-passenger dummy slanted forward at 45° and moving rearward, and the left wing completely detached from the fuselage. In frame 9, the pilot dummy is flexing rearward and the first-passenger dummy is bouncing upward and rearward.

In frames 10 and 11, the first-passenger-dummy's head has hit the roof while moving rearward in an arc. In frames 12 and 13, the first-passenger-dummy's head is no longer in contact with the roof and the upper torso continues to rotate rearward. The pilot dummy is seen flexing forward. In frames 14, 15, and 16, the pilot and copilot dummies are shown pitched forward into the instrument panel. The first-passenger dummy is shown against the seat back.

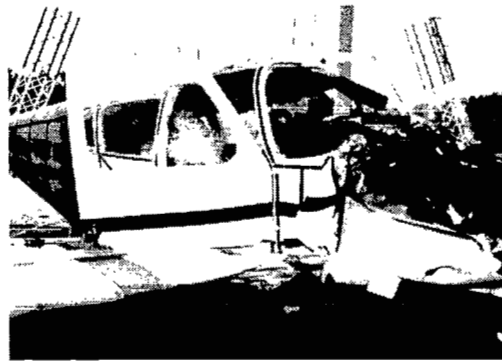
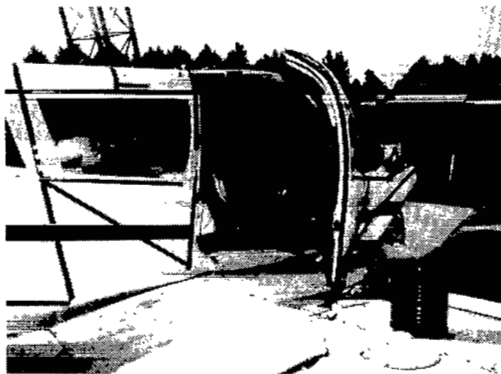
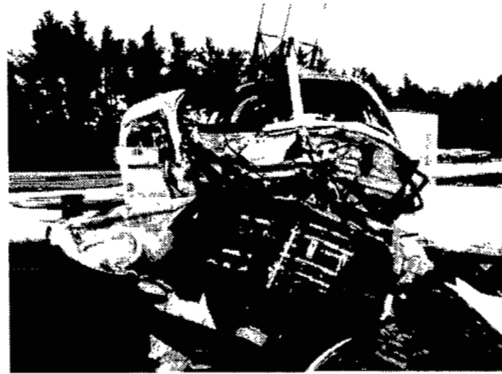
Figure 14.- Postcrash damage to test specimen in -30° (nose-down) test on soil.

Assessment of damage.— Postcrash photographs of the damage sustained by the airplane specimen are shown in figure 14. The livable cabin volume, although reduced, was maintained during the crash impact. Figure 14(a) shows the airplane in its final position resting on the fuselage and right wing. The left wing is shown detached and in front of the airplane. The engine top cowling has come off and is shown on the right side ahead of the wing. Figure 14(b) shows buckles on the wing leading edge and on the side panel ahead of the door, and also shows damage to the nose, windshields, and center post of the airplane. The degree of center-post bend is an indication of the protrusion of the fire wall into the cabin. The protrusion of the lower half of the fire wall into the cabin measured up to 51 cm and was more severe than the top half. Figure 14(c) shows a tear on the wing over the landing gear, separation of the right wing from the fuselage aft of the main spar, a fracture in the lower rear of the doorframe, and the copilot-dummy's knees bent up due to the reduced space from the seat to the fire wall. Figure 14(d) shows a bent propeller, a bent and fractured engine mount, a torn lower engine cowling, and a deformed fire wall. Figure 14(e) shows a fractured main-spar attachment to the wing and the broken hydraulic lines in the left wing. Figure 14(f) shows the floor and foot-control deformations in the copilot's side of the fuselage.

Other damage not shown in figure 14 were heavy buckling in the pilot's side of the fuselage and shearing of rivets in the left part of the roof to the left of the

pilot's window. It was also noticed that the pilot's window broke off, the pilot's seat pan tore through, and part of the pilot's control wheel fractured off.
